Manhole Inspection Summary

Manhole # S25KK_010MH

Insp Date: **8/28/07 9:49 AM**

Location Address: **1215 NORTH AVE**

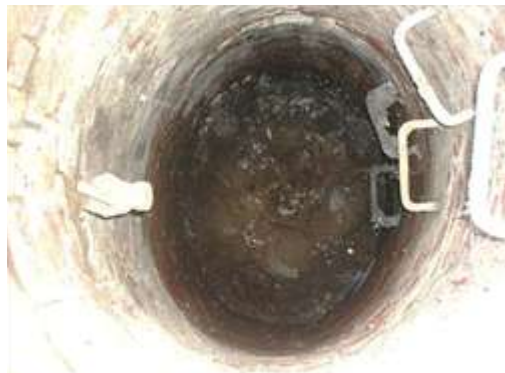
Top View

Corroded steps. Channel debris.

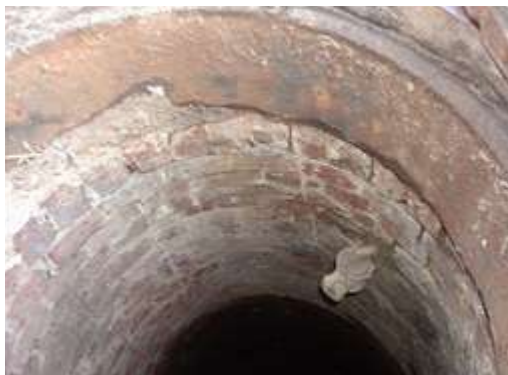
Defect

Frame leaks. Adjustment deterioration and infiltration. Corbel and Barrel infiltration - other side.

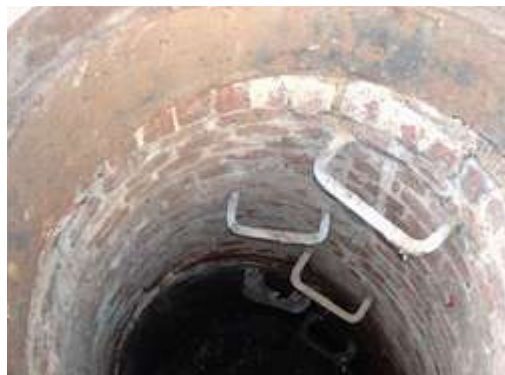
Defect

Frame leaks. Adjustment, Corbel and Barrel infiltration.

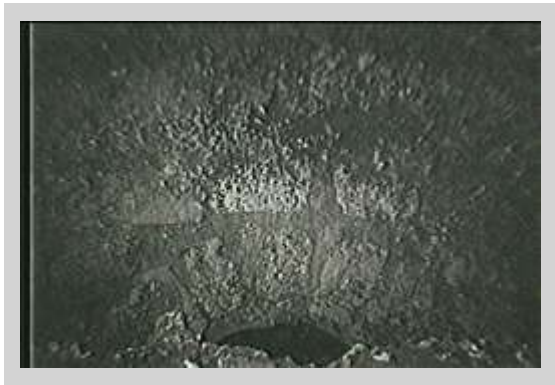
8 in. Circular Gravity Sewer
Pipe Out @ 12 O'Clock

Deposits: ☐ None ☒ **Mud** ☐ Sludge ☒ **Debris** ☐ Grease

Silt Depth: **6** (in.) Deposits Extent: **Heavy**
